# ***Disaster Response & Recovery Effort: Super Typhoon Mawar Andersen AFB, Guam***

**Bil Hawkins, PE, PMP**

**Air Force Civil Engineer Center**

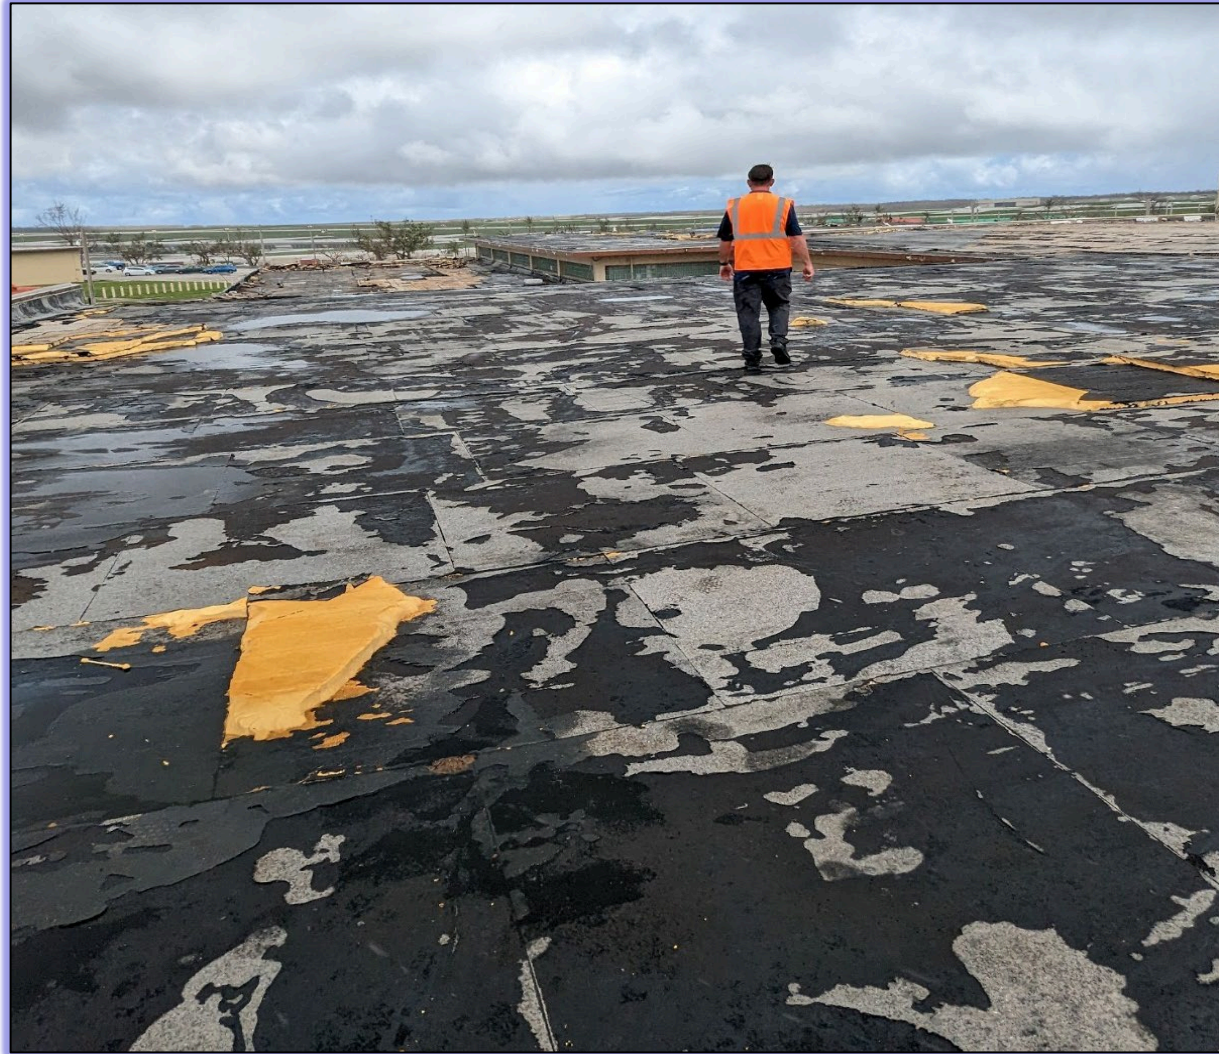
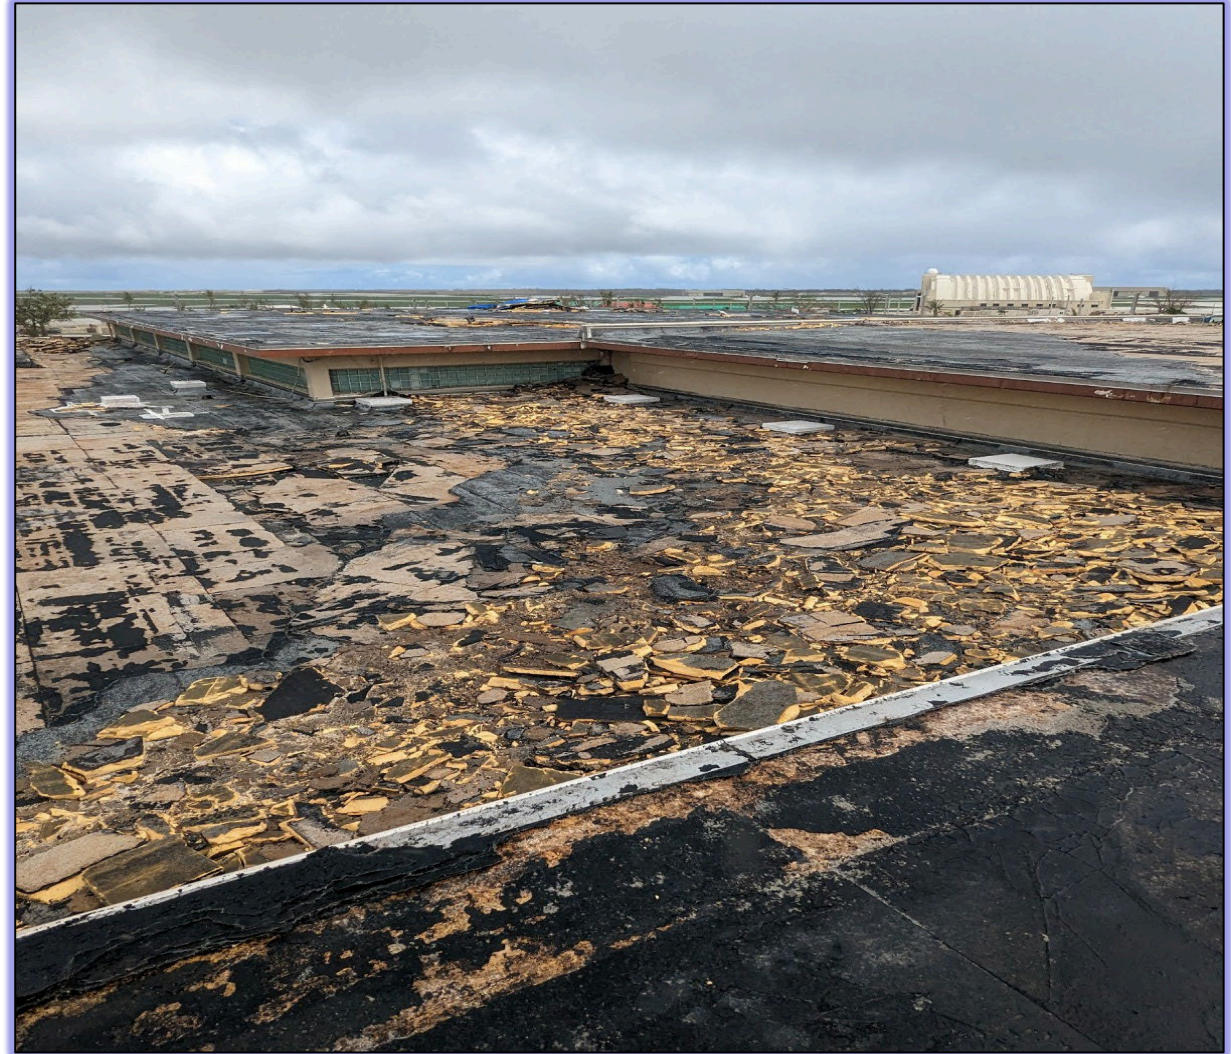
# Typhoon Mawar Andersen AFB Damage

## **Building Envelope Failures**

**Roofs**

**Roll Up Doors**

**Open Louvers in Walls – Over Pressured Rain (36-inches in six days)**

## **Exterior/Unprotected Equipment**

**HVAC Condensers**

**Lightning Protection Systems**
