# Where FCI Falls Short, a case study with Army National Guard

# Case Study 1: BLDG 2000 - FMS at Riverside, CA

# Case Study 2: BLDG 4113 - Dorm at Camp Roberts, CA

# Case Study 3: BLDG 2404 Battalion HQ at Camp Shelby, MS

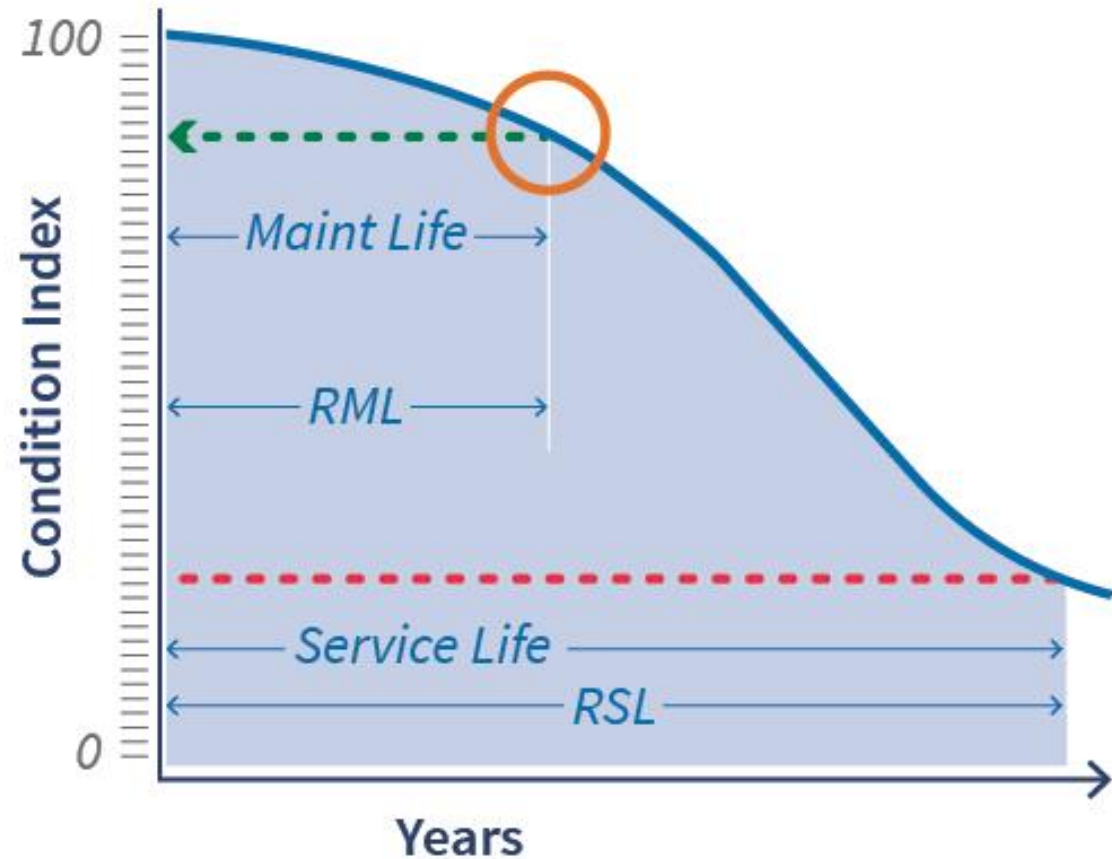
Source: D.R. Uzarski, Ph.D., P.E.

- Age based ratings use BUILDER's built-in degradation curves to calculate the condition index for a component
- Assessor's input the installation year, and the component's condition index is calculated using the percentage of the component's life cycle

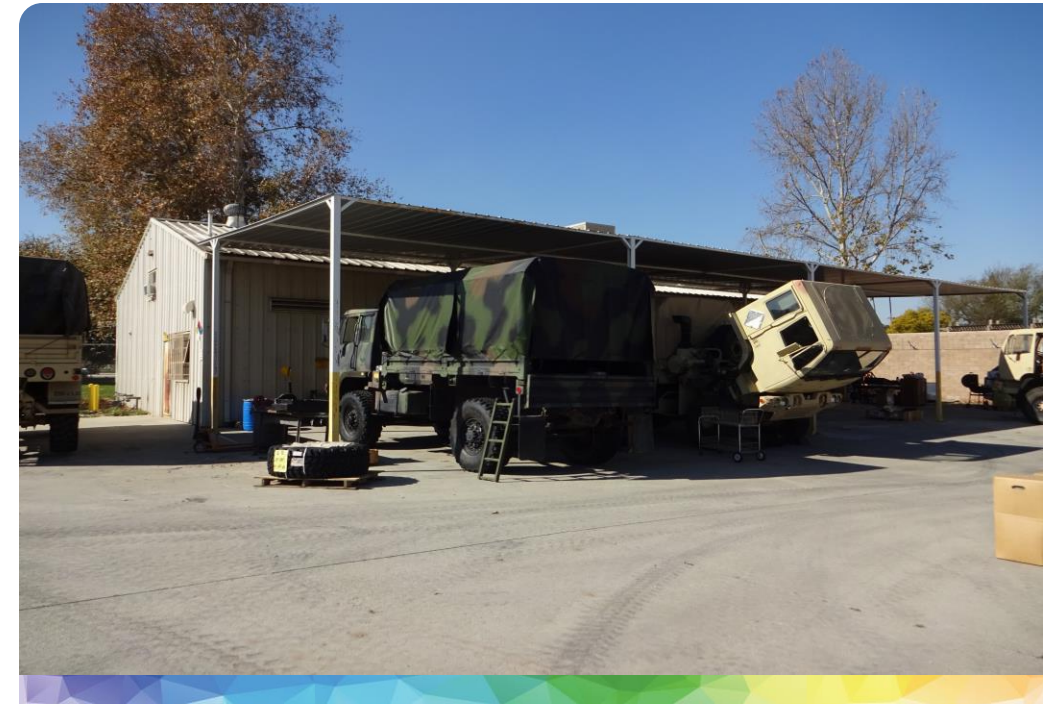
A10	B10	B20	B30	C10	C20	C30	D20	D30	D50	E10
90	89	64	55	79	86	80	67	59	34	80

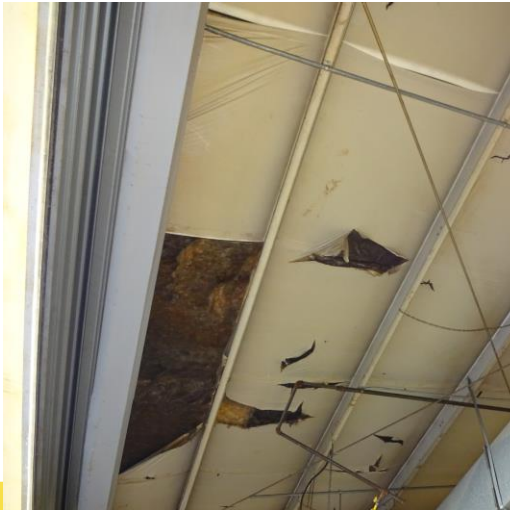
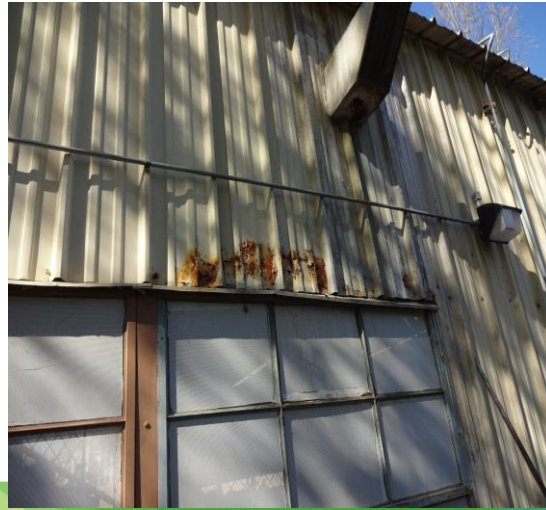
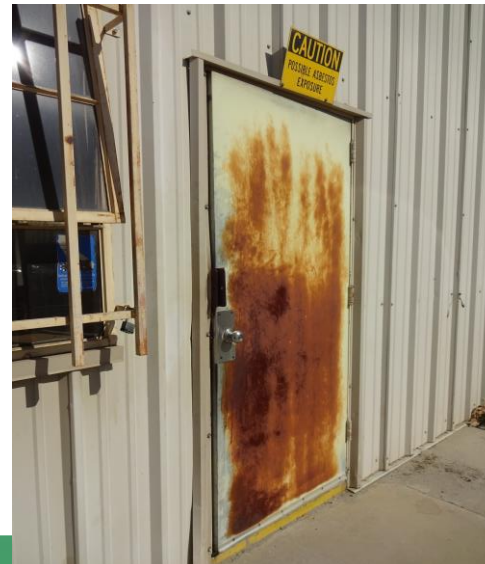
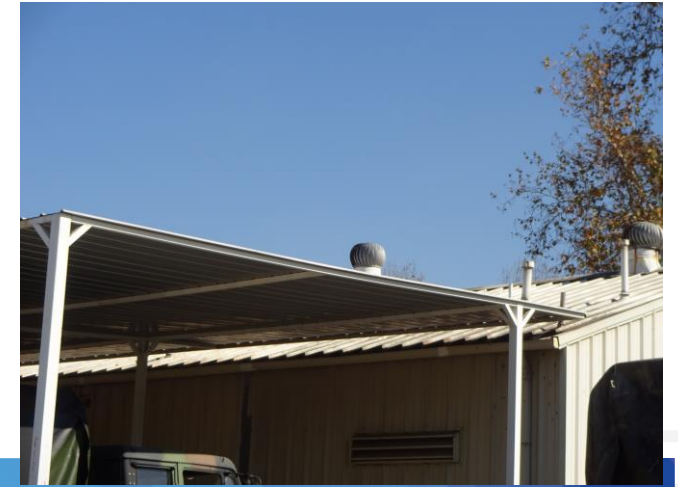
- Building had major roof leaks and a compromised exterior enclosure.
- A large, newer awning was added to the building, raising its overall rating.

- Generated Major Work Items Include (Items that affect FCI):
  - Replacement of electrical grounding system
  - Roof replacement (Main Roof Section has a CI of 33); Building roof rating significantly increased by new large accessory canopy roof.
  - Infrared heater repair
  - Vinyl tile flooring finish repairs
- On-Site Personnel & Assessors Noted:
  - Roof leaks over work areas that needed to be urgently addressed
  - Significant deterioration of finishes
  - Aging mechanical systems needing repairs

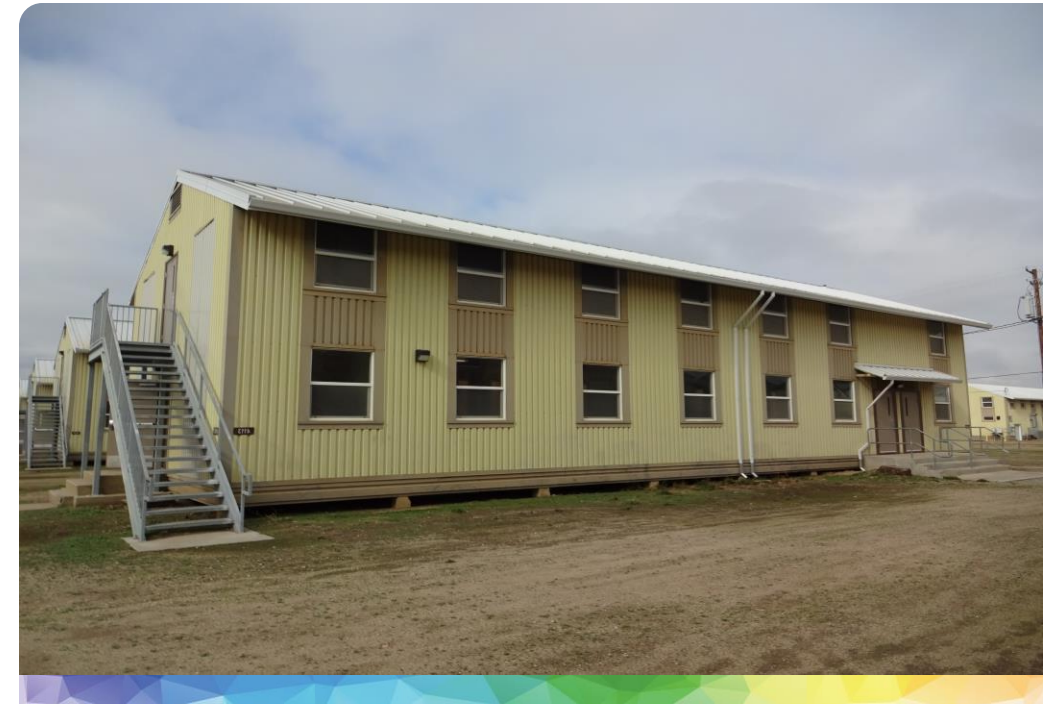
A10	B10	B20	B30	C10	C20	C30	D20	D30	D50
84	44	81	82	80	84	77	73	77	65

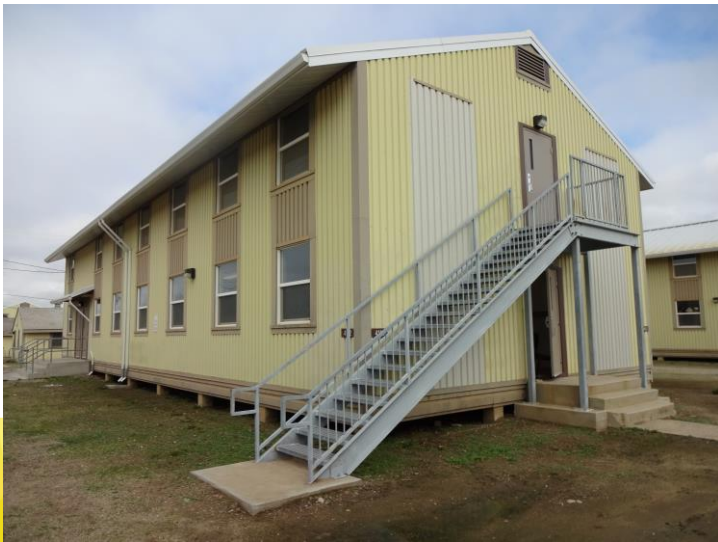
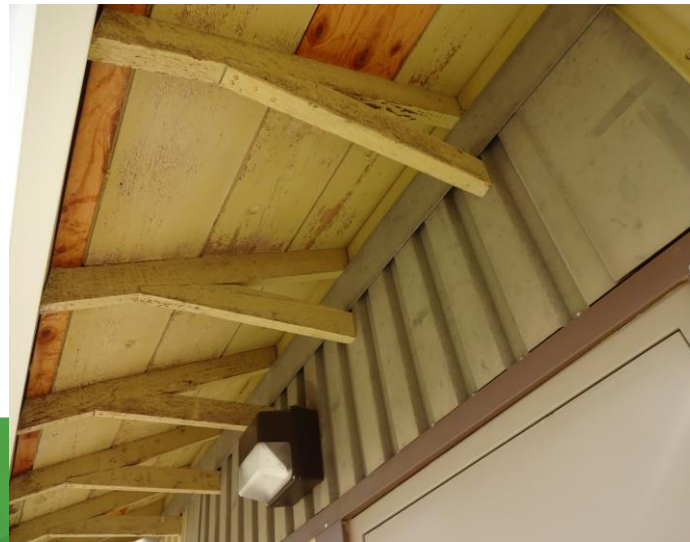
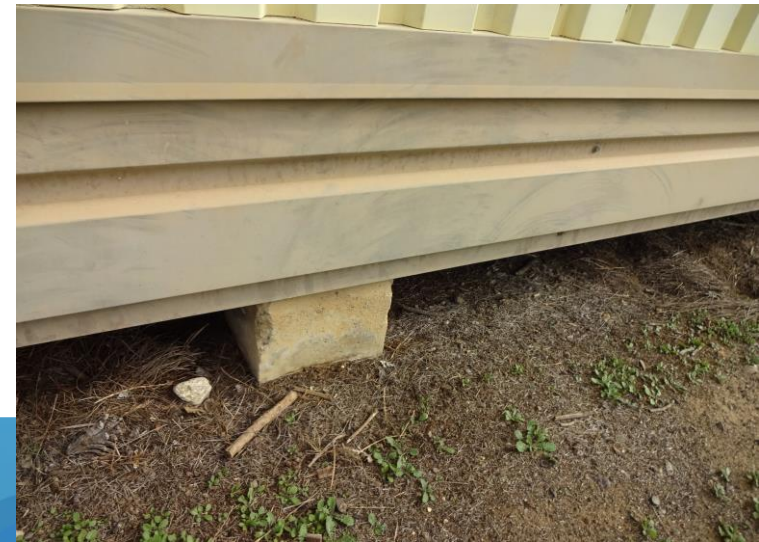
- Building is an original WWII structure that has recently undergone renovation.
- Buildings were re-wrapped and roofed, but over the original 1941 foundation & structure

- Generated Major Work Items Include (Items that affect FCI):
  - Replacement of Branch Wiring
  - Wall Finishes
  - Interior Lighting
- On-Site Personnel & Assessors Noted:
  - Insect damage to framing
  - Pile caps twisted from original configuration
  - Rot in exposed decking
  - General animal/insect infestation in building

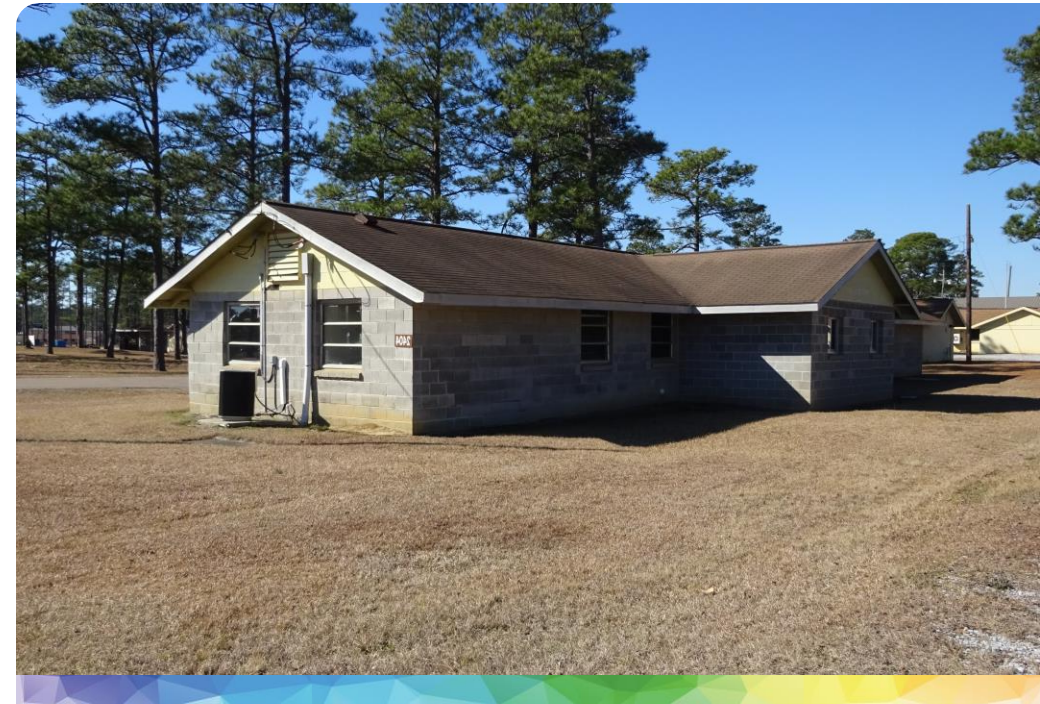
A10	B10	B20	B30	C10	C30	D20	D30	D50
<b>66</b>	<b>79</b>	<b>66</b>	<b>68</b>	<b>52</b>	<b>48</b>	<b>64</b>	<b>75</b>	<b>71</b>

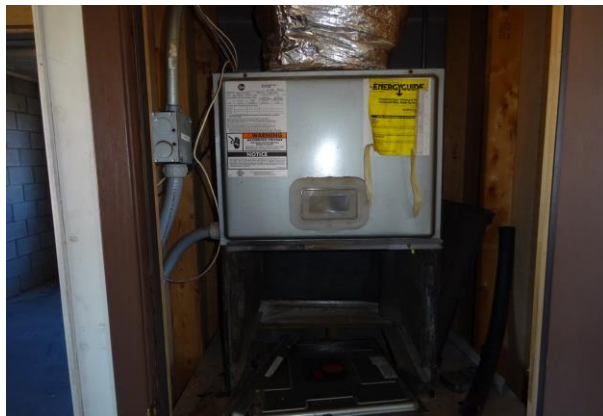
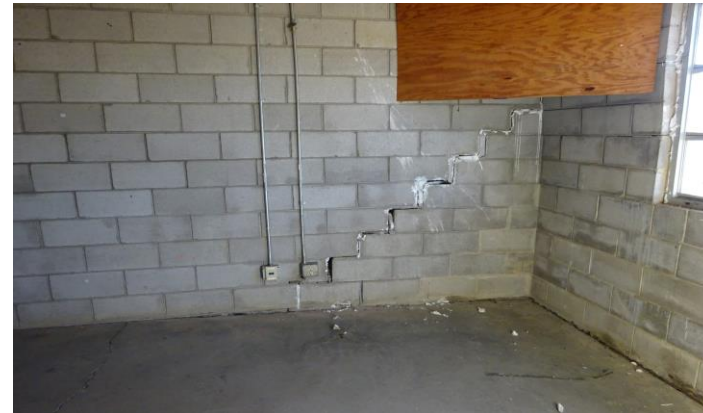
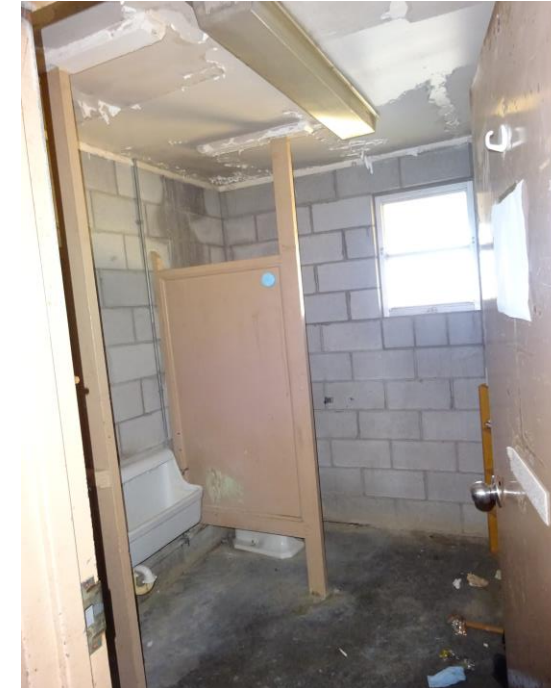
- Building is unpainted and unsealed CMU construction with a corner having significant structural cracking
- Aged and damaged interior finishes
- Aged and operationally impaired HVAC equipment

- Generated Major Work Items Include (Items that affect FCI):
  - Replacement of floor finishes
  - Replacement of exterior doors
  - Wall Repair (\$730)
- On-Site Personnel & Assessors Noted:
  - Southwest corner CMU wall has a 12 ft structural crack. Indication of a previous repair attempt.
  - Several areas across ceiling have peeling paint and ceiling is in poor condition
  - Noted deficiencies of HVAC system, as well as general age
