**US Army Corps
of Engineers**

CERL Technical Report 99/100
December 1999

ROOFER: Steep Roofing Inventory Procedures and Inspection and Distress Manual for Asphalt Shingle Roofs

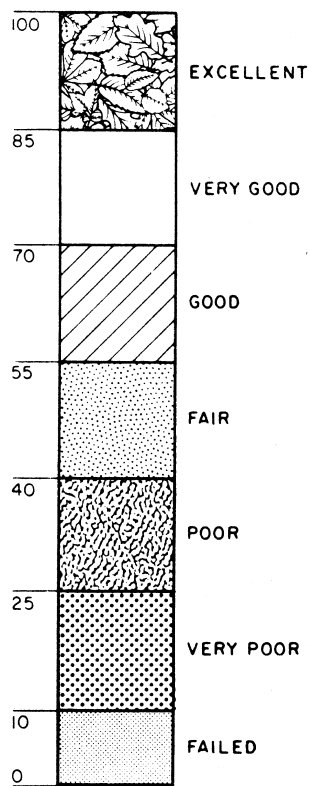
Figure 1. Flashing and Shingle Condition Indexes (FCI and SCI) and ratings.

Results of roof inspections are to be used in conjunction with the calculation procedures in Chapter 3 to determine the FCI and SCI and their corresponding condition ratings (Figure 1). Deduct value curves are in Appendix A, field measurement methodologies are in Appendix B, and samples of roof inspection sheets are in Appendix C. These flashing and shingle component condition indexes are combined to calculate a roof condition index (RCI) and provide an overall roof assessment.

Determine the corresponding descriptive condition ratings from Figure 1 for both indexes. For this data, FCI = 88 and SCI = 91, giving both the flashings and shingles an excellent rating.

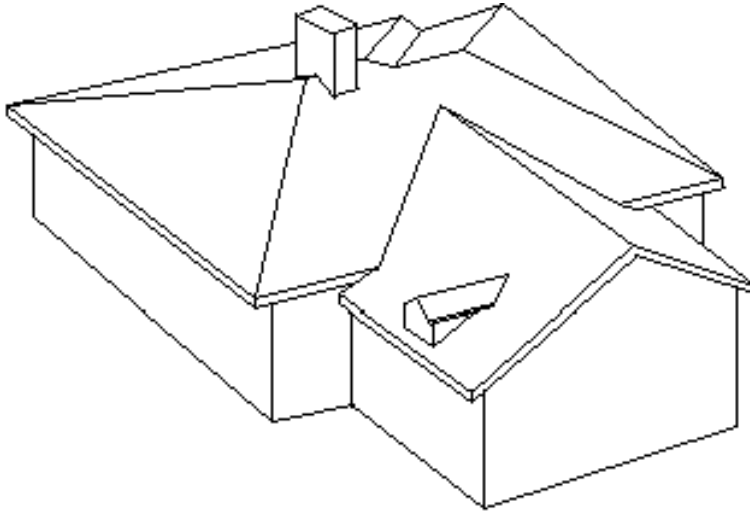
Figure 2. Example of a building roof comprising a roof section.

Building roofs are managed by units called “roof sections” for which all repair and replacement decisions can be made. To achieve this, each roof section is inspected and evaluated independently of other roof sections. As a rule, a building having a steep roofing system of approximately 10,000 SF or less should be managed as one section. Roofing on dormers and similar projections should be included with the main roof section. As an example, all exposed roof areas on the building shown in Figure 2 would comprise one roof section.

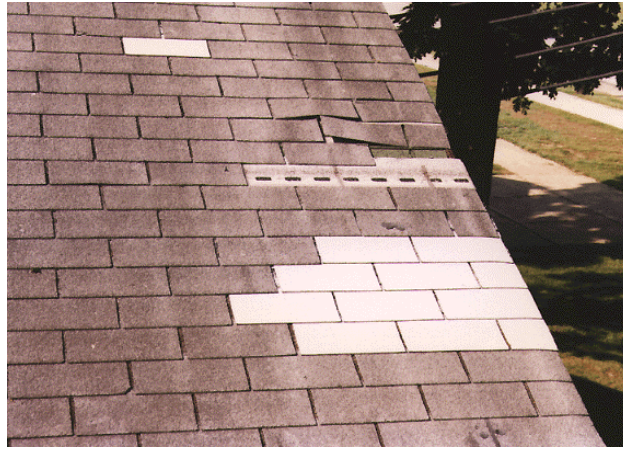
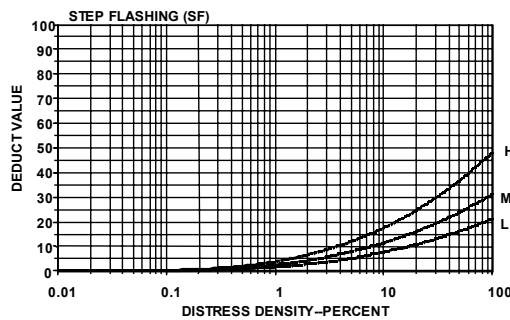
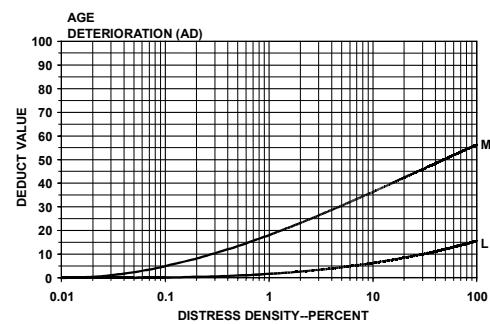
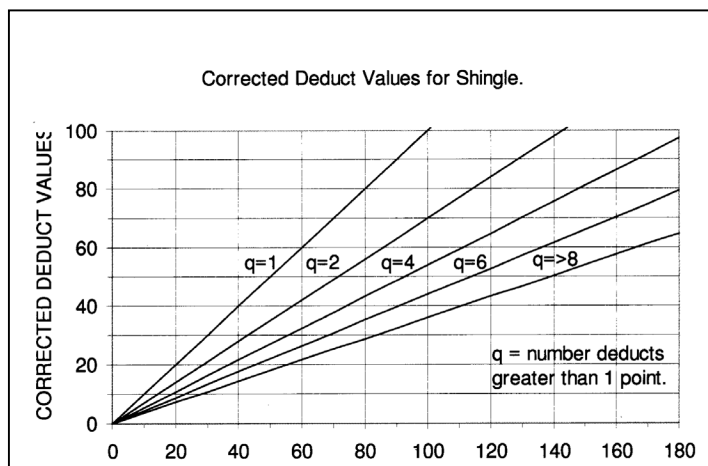
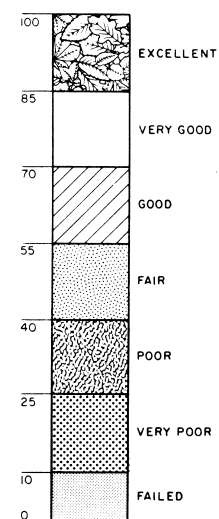
Step 1. Inspect roof. Determine distress types, severity levels and defects. Determine quantities and calculate densities.

Step 2. Determine deduct values.

Step 3. Compute corrected deduct value.

Step 4. Compute condition index.

As defined by the concepts and theories in previous technical reports (Shahin, Bailey, and Brotherson 1987a, 1987b; Bailey et al. 1993), the condition indexes reflect the (1) ability of the roof covering and its flashing components to perform their functions, (2) needed level of maintenance, and (3) waterproof integrity. The flashing and shingles of asphalt shingle roofs are evaluated to determine the FCI and the SCI. A thorough visual inspection must be conducted to identify the distress type, severity, and amount of each defect present. A distress type may have several different defects for a given severity level. The inspection must be carefully organized and planned to provide the necessary information for determining the flashing and shingle conditions. This chapter presents the overall process for visually inspecting asphalt shingle roofs and computing FCIs and SCIs, as shown in Figure 8.

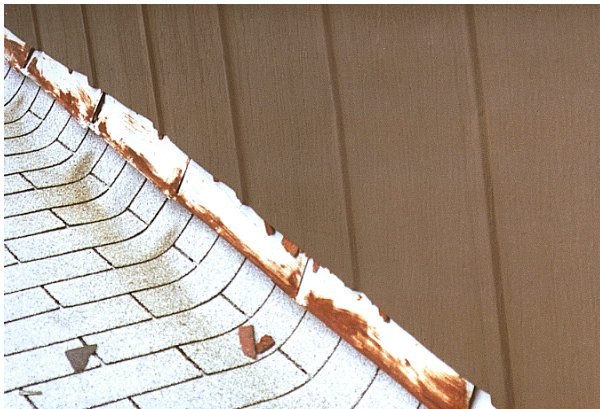
SF-L-2.

1. Loss of protective coating or corrosion of step flashing.
2. Overlayed roof system shingles are not step flashed.
3. Coverage of less than one step flashing unit per shingle course exists.

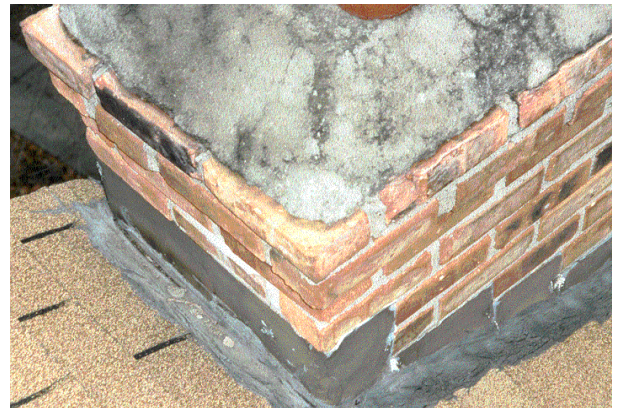
SF-M-4.

1. Vertical leg of step flashing is less than 4 in. high.
2. Bent, deformed, or wide gaps in vertical leg of step flashing.
3. Loose or displaced step flashing.
4. Vertical joints between step flashing pieces have been sealed closed.
5. Continuous “L” flashing exists instead of incremental step flashing.

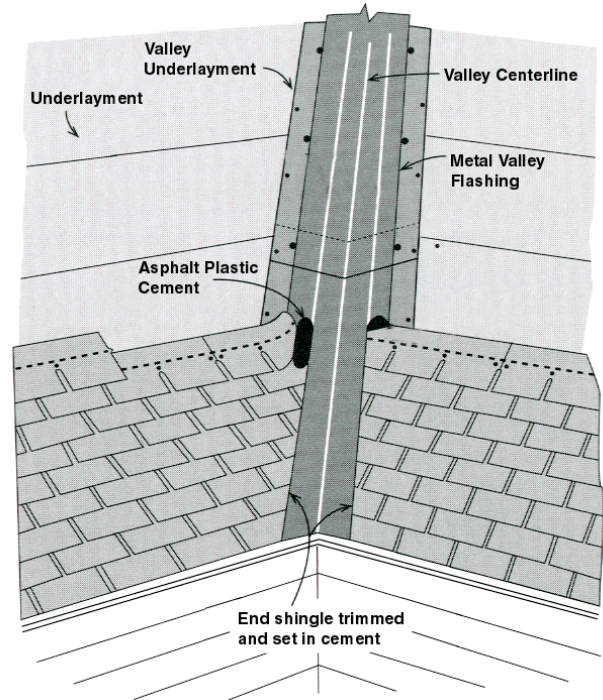
Valley Flashing - Open

Roof valley flashings are formed when two sloping roof sections intersect to form a "V". Water from both sections of roof runs through the valley making it especially vulnerable to deterioration and leakage. Valley flashings for asphalt shingles may be of three types: (1) open valleys lined with sheet metal or mineral-surfaced asphalt roll (composition) material, (2) closed cut valleys having shingles on one side of the valley cut on an angle parallel with the valley, and (3) woven valleys lined with interwoven asphalt shingles from the adjoining roof sections. All three types of valley flashings should have underlying asphalt roll material.

Description: Roof valley flashings are formed when two sloping roof sections intersect to form a "V". Water from both sections of roof runs through the valley making it especially vulnerable to deterioration and leakage. Valley flashings for asphalt shingles may be of three types: open valleys lined with sheet metal or mineral-surfaced asphalt roll (composition) material; closed cut valleys having shingles on one side of the valley cut on an angle parallel with the valley; and woven valleys lined with interwoven asphalt shingles from the adjoining roof sections. All three types of valley flashings should have underlying asphalt roll material.

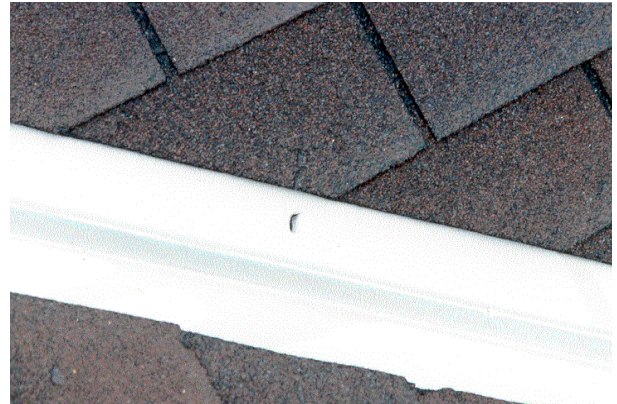
VF-H-1.

1. Splits or holes in valley flashing with underlayment or substrate exposed.
2. Loose or missing valley shingles with underlayment or substrate exposed.
3. Exposed fasteners within 12 inches of centerline of open valley.

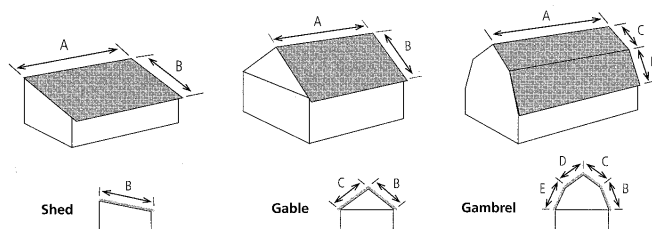
Figure 13
Examples of simple roofs

For the shed roof which has only one rectangle, the area is found by simply multiplying the rake line by the eaves line, or $B \times A$. The gable roof is comprised of two rectangular planes and its area is found by multiplying the sum of the rake lines by the eaves line,

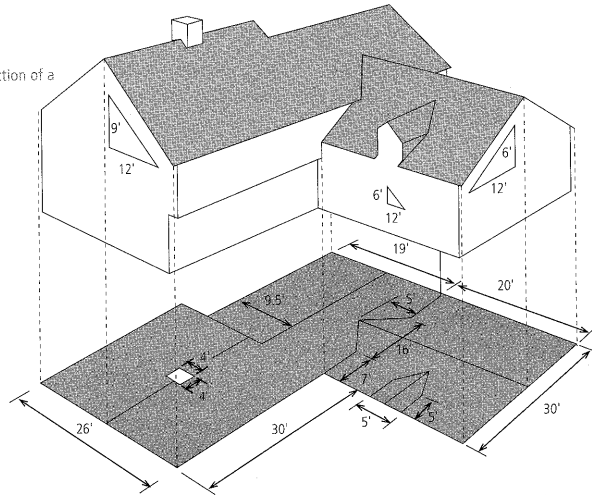
Figure 17
Horizontal projection of a
complex roof

- ① Calculate the horizontal area under the 9" slope roof.
- ② From this gross figure, deductions must be made for the area of the chimney and for the triangular area of the ell roof that overlaps and is sloped differently from the main roof.
- ③ Calculate the net projected area of the main roof.
- ④ Calculate the horizontal area under the 6" slope roof.
